Preliminary studies for intervention, interpretation and value enhancement of Tower of Don Fadrique (Albaida, Seville, Spain)

A. Graciani, J.J. Martín, G.M. Mora, F.J. Alejandro & J. Canivell

Seville University, Seville, Spain

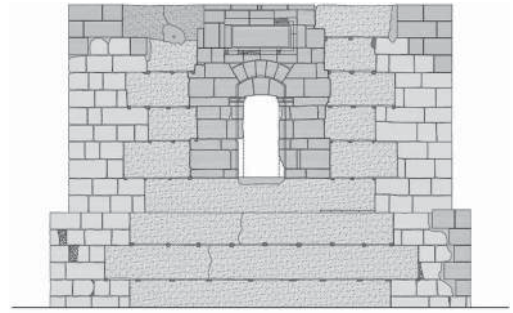
The most interesting sides of the tower are the NW (Fig. 1) and the SW face, where appear the main elements contributing to clarify the tower's origin.

Figure 1. NW face of the tower (L.A. Núñez Arce).

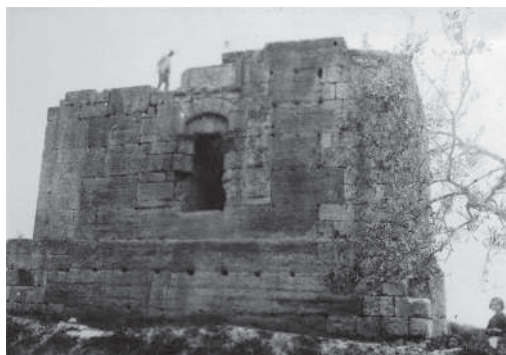
The original Almohad building was raised at the start of the 13th century. It was attached to a walled recinct of which we have found no remains to date. However, we have traced its existence in the course of our research. In fact, images from the 1930s preserved at the Photography Library of the Art Laboratory of the University of Seville (Fig. 2), allow us to refute previous hypotheses and confirm that the Torre Mocha was not a guard tower or a Fort Tower (Ortiz de Zúñiga 1975) in contrast to the San Antonio Tower, a nearby coeval building.

Figure 2. Image from the 1930s (Photography Library of the Art Laboratory of the University of Seville).

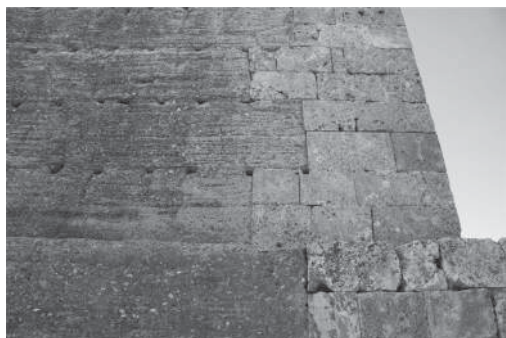
The tower was built of mixed rammed-earth and stone masonry (Fig. 3). The chain was carried out with coursed ashlar of local stone and some pieces were re-used. The courses have a height ranging between 0.88 to 0.90 m and are separated by a 0.03 m thick layer of lime. It is executed with overlapping formworks creating 6–7 meter sections of continuous rammed earth between the stone chains. Its NW face, towards the plain, must have housed its original entry point, of which there is currently no evidence.

Figure 3. NW wall of the tower (A. Graciani).

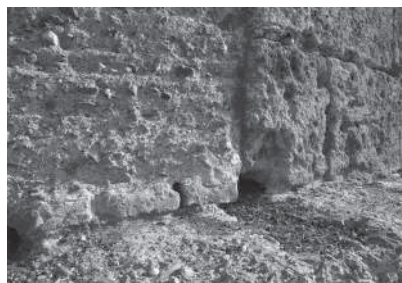
Material damage is more evident and is due to erosion (especially bad in the topmost courses lacking adequate roofing). The surface loss of mass overall in the walls is significant, with a consequent exposure of the lime mortar layer between courses; however, it can be classified as of slight importance due only to the highly cohesive mortar resulting from the high-quality execution and the high proportion of lime.

The superficial damage is limited to adhered stains (no crust formation) arising from washing by rainwater which, upon filling the exterior network of pores and concavities with particles, slightly darkens the wall's surface and highlights its washed outer face.

Figure 4. NW face of the tower (detail) (A. Graciani).

tion (roof and covering), to the high exposure, and to the lack of regular maintenance. Therefore, it is advisable to apply certain preventative measures in the medium or short term to reduce the hazard of existing erosion progressing. Otherwise, what is currently superficial loss of mass and stains could degenerate with a certain degree of probability into more serious damage.
