PROCEEDINGS OF THE FIRST INTERNATIONAL CONFERENCE ON RAMMED EARTH  
CONSERVATION, RESTAPIA 2012, VALENCIA, SPAIN, 21–23 JUNE 2012

## Restoration of monumental rammed earth buildings in Spain between 1980 and 2011 according to the Archives of the IPCE

**ABSTRACT:** This study has been carried out as part of the research project called “Restoration of Rammed Earth Architecture in the Iberian Peninsula. Technical criteria, results and perspectives” (ref. BIA 2010-18921), funded by the Spanish Ministry of Science & Innovation. The research presented here consisted in reviewing the collection of the archives of the Cultural Heritage Institute of Spain (IPCE), with a view to providing an initial approach to the interventions on buildings made of rammed earth in the last thirty years (from 1980 until the present day) and funded by the Ministry of Culture of the Spanish Government. The paper strives to provide a preliminary global analysis that will make it possible to draw certain more specific conclusions about intervention criteria and the construction solutions adopted in the different interventions.

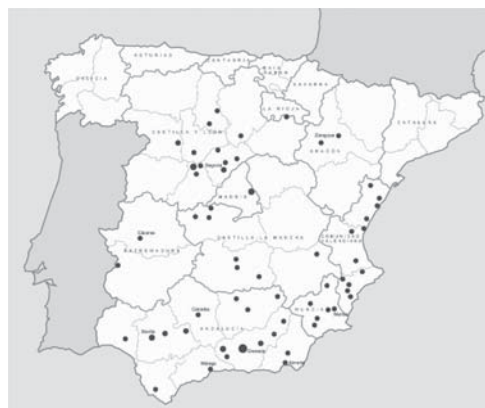
Figure 4. Map of the interventions studied.

From the point of view of geographic analysis of these buildings, three autonomous communities had the largest number of files: Andalucía, with 17 different buildings; Castilla y León, with 13 interventions and the Comunidad Valenciana, with 12 buildings (Figs. 3 and 4).

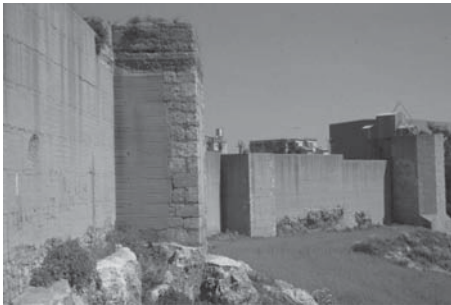
Figure 6. General view of the Niebla city walls after restoration (Huelva, Spain) (Vegas & Mileto).

In some interventions reconstructions are seen as partial volumetric restitution, as Ismael Guarner González writes when speaking about his intervention on the walls of Niebla in 1980 (Fig. 6). “Restore the monument while striving to endow it with a more defined image more like what it once used to be, without having to reproduce the original volume” (File PI 0102.09 of the IPCE archives).

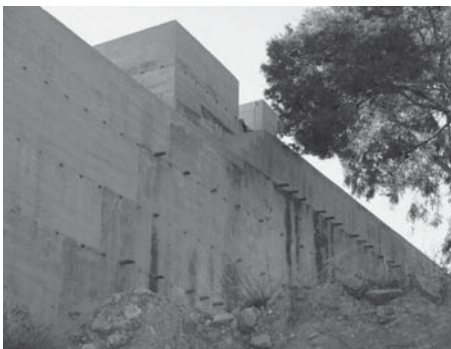
Figure 7. Part of the external wall of the castle of La Mola (Novelda, Alicante, Spain) with the regularization of the volumes (Vegas & Mileto).

This criterion can also be seen in the intervention on the Castillo de la Mola (Novelda) in 1983 (Fig. 7), where Ramón Valls Navascués stated, “This project is aimed at consolidating the existing ruins, arranging the current volumes in such a way that by completing the shapes which can be deduced from the existing parts, the appearance, the colour, the well-known romantic character of this type of building and this one in particular will

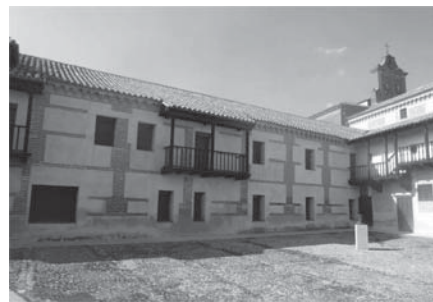
Figure 8. Restored building at the first patio of the Palace of Juan II at Madrigal de las Altas Torres (Ávila, Spain) (Vegas & Mileto).

In some dossiers they go as far as to claim that the intervention must be limited to the strictly necessary, as Mariano Bayón Álvarez says in his report on the intervention on the Palacio de Juan II (Madrigal de las Altas Torres) in 1981 (Fig. 8), affirming that “the overall restoration works try to adjust to contingent, really direct, compulsory and necessary principles, without making any concessions to rhetoric” (File PI 0482.01 of the IPCE archives).

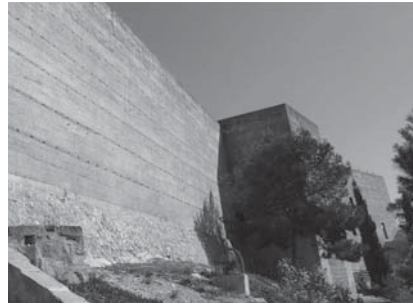
Figure 9. Restored wall of the castle of Petrel (Alicante, Spain) (Vegas & Mileto).

The connection between the original material, rammed earth, and the new material, concrete, depends on the construction detail proposed in each case, but the detail proposed for the Castillo de Petrel in 1982 is common: “Restoration of the surface of the wall with mixed cement and lime concrete, with timber planks fixed with wire, which will be cut off when the planks are removed and the putlog holes will be left visible. Dovetail profiles will be used to attach the rammed earth wall to the existing fabric” (File PI 0988.03 of the IPCE archives) (Fig. 9).

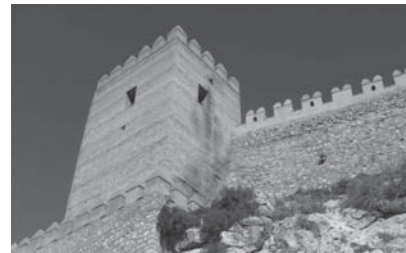
Figure 10. South wall of the Islamic castle at Almería (Spain) (Vegas & Mileto).

Puig Álvarez suggests “consolidating with masonry in the existing gaps, first proceeding to clear away the rubble at the base of the wall, to which will be added the rubble from chipping off all the false rendering and plaster in order to restore a stony appearance to the wall, which, even if it is not quite the original Arabic rammed earth, would be more appropriate than all the Christian reconstructions” (Fig. 10) (File PI 0001.01 of the IPCE archives).

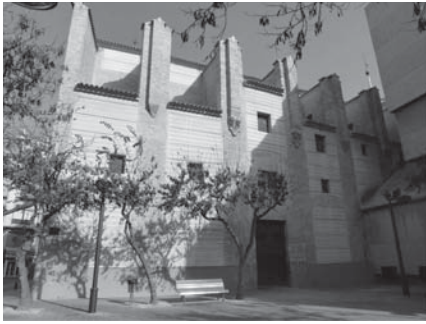
Figure 11. South façade of the Church of La Merced (Murcia) (Vegas & Mileto).

In civil and religious architecture, the interventions proposed are different, because, as we suggested above, the pathologies that affect these buildings are usually different too. Interventions on these buildings are usually on the surfaces, as we can see in the intervention on the Iglesia de la Merced (Murcia, 1981), where they proposed “the recuperation of the rammed earth fabrics, to which end an average of 5 cm will be removed from all the damaged surfaces, which will then be rebuilt with lime mortar and the old surfaces will be duly treated” (File PI 0938.04 of the IPCE archives).

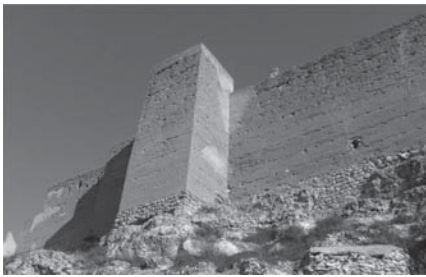
Figure 12. Restored wall of Jorquera (Albacete, Spain) (Vegas & Mileto).

chosen also depend on the original building techniques. For example, in the intervention on the walls of Jorquera in 1982 (Fig. 12), they said “as the building material is not stone but mortar, we do not think the solution is to clamp the cracks. Therefore we prefer to fill them in with lime mortar, stone and local soil, to which formwork will be applied in the places where it is deemed necessary and a finish similar to the original will be applied” (File PI 0363.03 of the IPCE archives). In other cases, such as the intervention on the church in Écija in 1983, since it is rammed earth confined between brick buttresses, the solution proposed is completely different: “the surface is cracked just between the two vertical joints that define the rammed earth walls. We propose to consolidate this wall by clamping these cracks by means of toothers or brick repointing” (File PI 0157.04 of the IPCE archives).
