**PROCEEDINGS: International Seminar Theory and Practice in Conservation.  
A Tribute to Cesare Brandi**

**“The conservation of earth architecture: The contribution of Brandi’s theory”**

**Mariana Correia**

**Maria Fernandes**

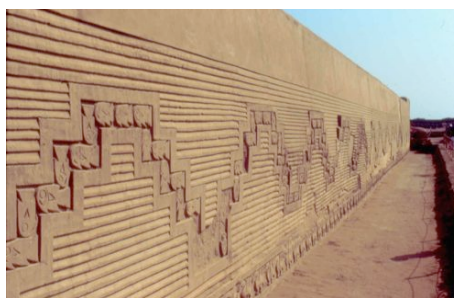
Fig. 01 - Tschudi Palacio, Chan Chan, Peru. Repair of the lacunas with reconstruction of architectonic surfaces.

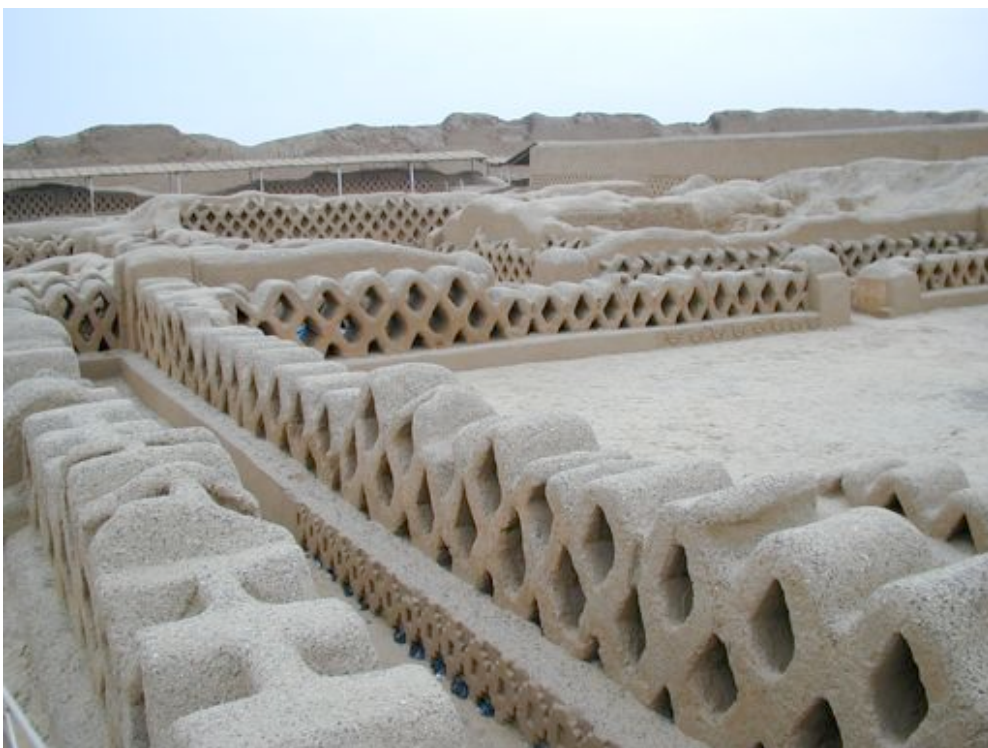
Fig. 02 – Tschudi Palacio, Chan Chan, Peru. Know-how of the adobe constructive technique.

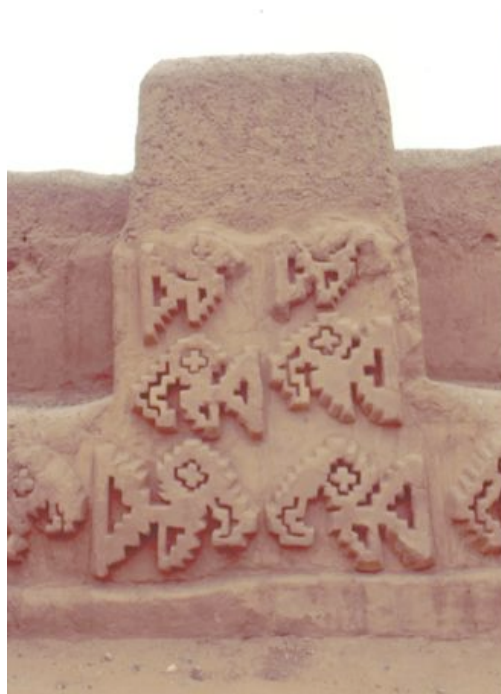
Fig. 03 - Tschudi Palacio, Chan Chan, Peru. Top protection.

The minimum intervention principle is mostly used on archaeological sites (13). The interventions based in protecting earth structures on the top (capping) and surfaces, with compatible materials are common used in earth structures. It is indispensable, when following the principle of minimum intervention to research and acquire a good knowledge concerning the object, material and its techniques, so adequate interventions are applied. This principle also helps to keep the unity, but especially the authenticity of the original object.

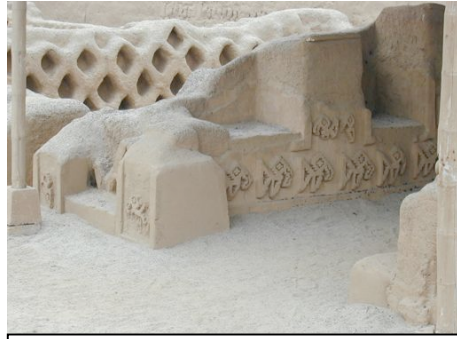
Fig. 04 - Tsudi Palace, Chan Chan, Peru.  
Protection layer on the top of the walls.
